**PRESSURE ACTIVATED LEAF SEAL
TECHNOLOGY READINESS TESTING**

ABSTRACT

This paper continues the evaluation of Pressure Actuated Leaf Seals (PALS) technology readiness for shaft and shroud sealing in power generation and aerospace applications. Seal designs tested are prototypical and constructed using processes appropriate for volume production. Results include both static and dynamic seal leakage measurements running against a 5.1in (130mm) diameter smooth surface test rotor and another that simulates sealing against turbine blade shrouds. A further test was undertaken using a 2D static rig that determined acoustic noise experienced during testing was attributed to leaves vibrating at their natural frequency as a result of inter-leaf gaps. The dynamic simulated shroud test includes steps, duplicating small discontinuities of adjacent shroud sealing surfaces and slots to inject air radially under the seal leaves as may occur between shrouds on blades with a high degree of reaction. Consistent seal performance over 15 hours confirms suitability for turbine blade tip applications. Controlled deflection of PALS leaves with operating differential pressure is effective for startup rub

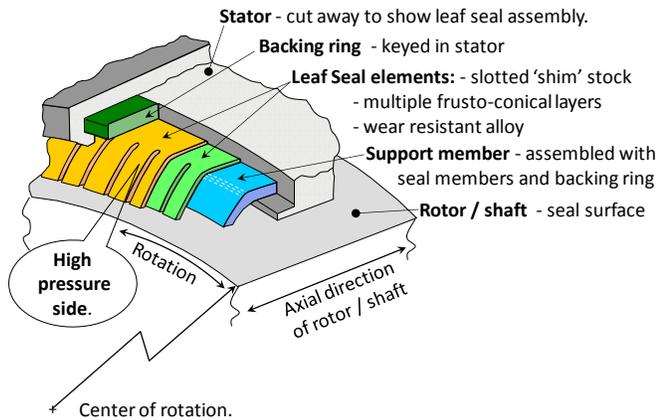
Figure 1: Pressure Activated Leaf Assembly

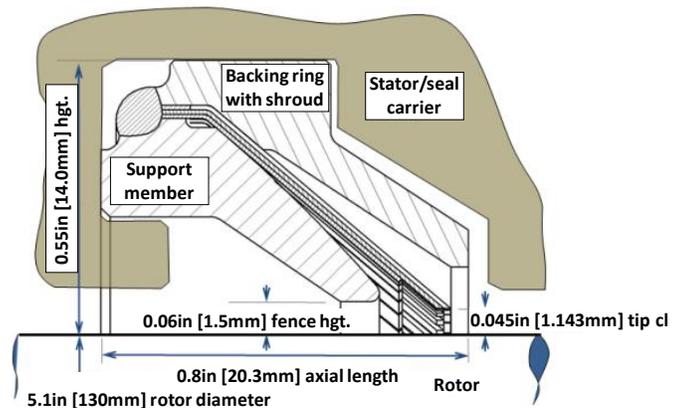
Figure 2: PALS prototype Seal Section

An installed leaf tip clearance of 0.045in (1.14mm) was chosen to illustrate PALS large cold clearance assembly to avoid seal rubs during startup and subsequent closure with the rotor as pressure across the seal increases to 80psid (550kPa), the test seal design pressure. Seal leaves are designed for desired deflection by selection of their length, thickness, number of leaf layers, support member radius, angle with respect to rotor axis

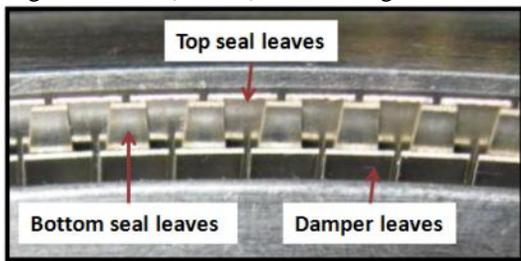
and fence height along with mechanical properties of the seal leaf material. Haynes 25 material in the annealed condition was chosen for the seal leaves of this design because of its wear qualities, suitability for use in other high temperature seals and availability in 0.010in (0.25mm) thickness. There are 2 layers of sealing leaves and a shorter, damping leaf, beneath them that is in register with bottom seal leaf as shown in Figure 3. Space between adjacent bottom seal leaf tips assures that seal pressure drop occurs across top seal leaves. As leaves are pressure loaded they elastically deflect into compliance with the support member contour. Bending stress is held well below material yield stress for long cyclic life without high cycle fatigue. Leaf deflection and stress are typically analyzed using beams in bending elastic analysis. FEA was also performed for this design. The difference in natural frequency of the shorter damper leaves mitigates occurrence of leaf oscillation. Fence height is 0.06in (1.5mm) in this design.

Figure 3: Leaf Tip Detail, LP Side

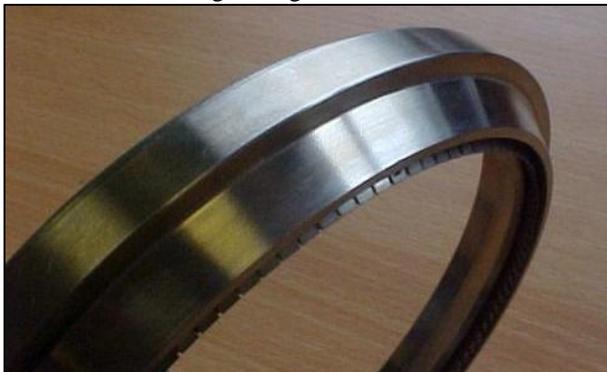
There are 120 seal leaves in each leaf layer that are cut by wire EDM from sheet. Each leaf layer strip is then bent to the design leaf angle plus some interference of upper leaf tips with lower leaf layers to assure intimate leaf contact as strips are laid up about the cylindrical portion of the support member. When assembled with the backing ring, parts are joined by welding as shown in Figure 2. The final fabrication step is a wire EDM trim of the seal leaves while mechanically constrained in the fully deflected position. This provides a precision seal ID for desired clearance or ‘wear-in’ with respect to the rotor. The finished test seal is shown in Figure 4. Prominent in the picture is the shroud portion of the backing ring that protects seal leaves from handling damage.

Figure 4: PALS 5.1in (130mm) Diameter Test Seal

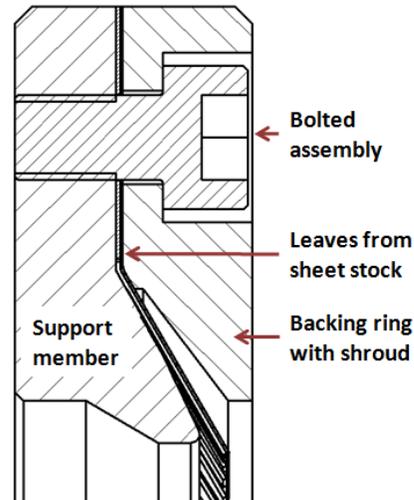
An alternate PALS configuration utilizes seal leaves that are cut from a sheet and bent out of a radial plane to assemble tangent with the support ring radius. A cross-section of this PALS configuration in Figure 5 shows mechanical assembly rather than welding. It accommodates those applications where there is limited axial seal envelope length but space for a taller seal. Seals of this configuration have been fabricated and tested with seal leakage comparable to the results presented below.

Figure 5: PALS from Sheet Stock

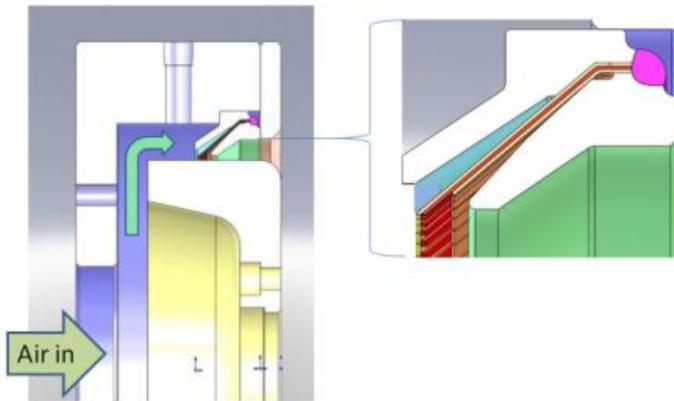
The PALS test design installation in the 5.1in (130mm) test rig is illustrated in Figure 6 and Figure 7 photos. Static and dynamic tests were conducted to evaluate sealing performance against a conventional smooth rotor surface using rotor disks of various sizes. Rotor disk material is uncoated Aubert & Duval 819B steel, a Ni-Cr-Mo alloy. The PALS LP side exhausts to atmosphere from the test rig.

Figure 6: Illustration of PALS in 5.1in (130mm) test rig

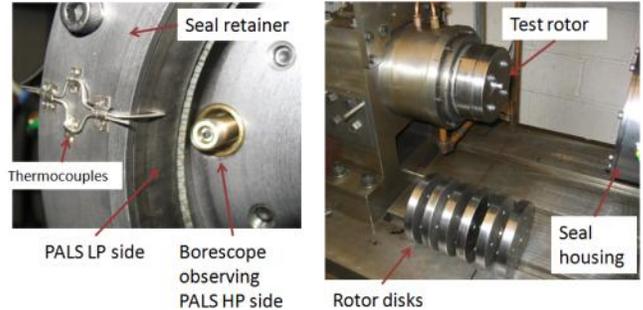
Figure 7: Photos of PALS installation in the 5.1in (130mm) test rig

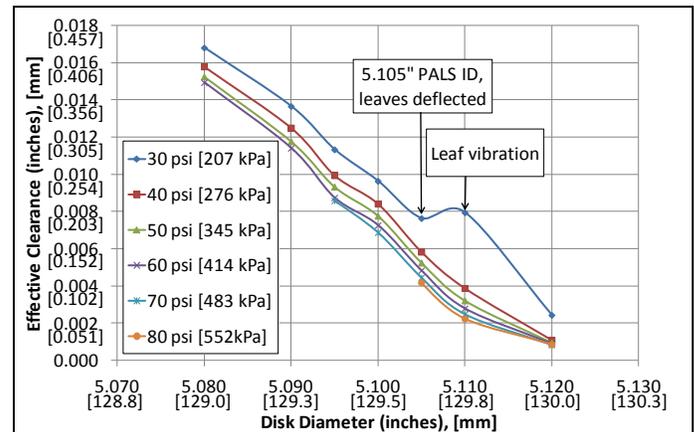
Initial tests were static, without rotor rotation, to evaluate PALS closure with pressure and seal leakage with rotor disks of different diameter ranging from interference with deflected PALS leaves to a clearance of 0.012in (0.3mm). The test seal bore diameter with seal leaves mechanically compressed was 5.105in (130mm) for this test. The un-deflected leaf bore was 5.185in (132mm). Static seal leakage verses rotor disk size is plotted in Figure 8 up to 80psi (552kPa). Flow measurements, used for calculation of effective clearance, were not stable below ~30psi (207kPa) and there was a loud tone. The one data point in Figure 8 that is above the line formed by the remaining 30 psi (207kPa) points is attributed to increased effective clearance due to leaf vibration.

Figure 8: PALS Clearance with Various Static Disk Sizes

Static and dynamic testing in the 5.1in (130mm) test rig continued to evaluate seal performance at higher pressures. Figure 8 shows that PALS can achieve a very tight clearance over a wide range of pressure when disk OD approaches seal ID. Since PALS leaf members are thin, 0.010in (0.25mm) in this case, a primary test objective was to assess the prospect of sizing the seal ID, by ‘wear-in’ engagement with the operating rotor, without hazard to the rotating seal surface or PALS. Doing such a ‘wear-in’ would eliminate seal leakage from the run-out and mis-alignment of seal mounting hardware when seals are designed to avoid shaft contact. PALS pressure actuation of leaf tips from a large inoperative clearance to a small operating clearance provides means of avoiding startup seal rubs caused by rotor dynamic shaft whirl traversing critical speeds coming up to operating conditions. Avoiding startup rubs, a PALS can return to small effective seal clearance established by the initial ‘wear in’.

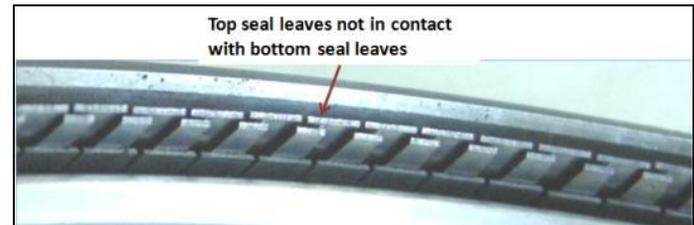
contact with underlying leaves, Figure 9. This finding was recognized as the probable cause of the noise. However, a decision was taken to build a small 2D test rig and thoroughly rule out other possibilities that may be contributing to it. That 2D rig and test program are discussed in the following section. It was undertaken out of concern for prolonged off-design operation at low pressure that could result in high cycle fatigue seal failure.

Figure 9: Test Seal Leaf Tips

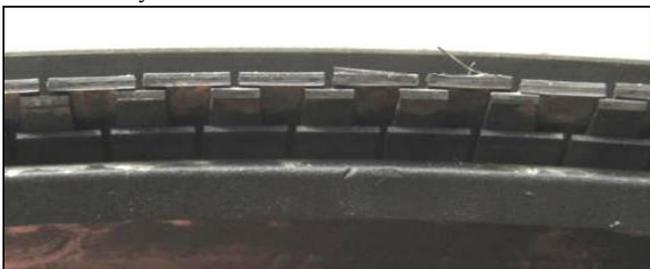
Figure 10: Leaf Tip Burr - Post Wear-in (View from Bottom)

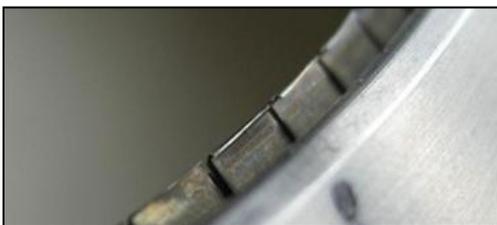
Figure 11: Leaf Tip Burr - Post Wear-in (View from Top)

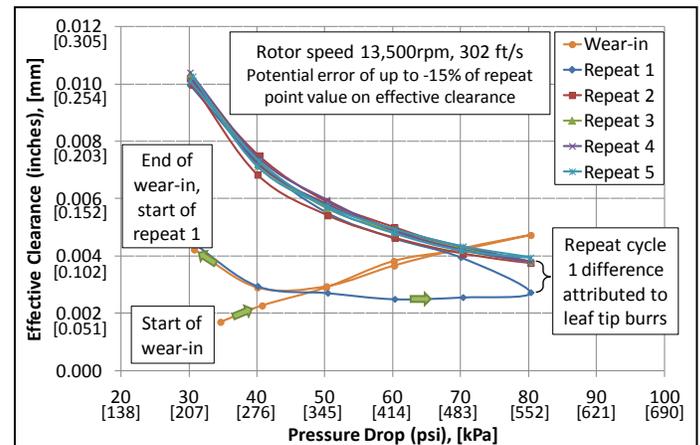
Figure 12: PALS Dynamic Test Clearance During and After Wear-in

Figure 12 is a plot of effective clearance measured during the ‘wear-in’ and 5 repeated dynamic cycles of pressure to 80 psid (552kPa) while maintaining 13,500RPM rotor speed. Irregularities during ‘wear-in’ and the first repeated cycle are attributed to shedding of burrs from seal leaf tips. Effective clearance during the five repeat dynamic pressure cycles track very closely indicating stable and consistent PALS closure with pressure.

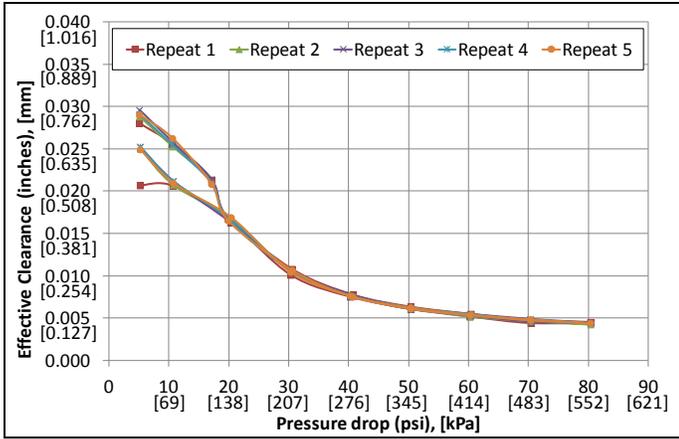
Repetitive static tests to 80 psid (552kPa) were performed after the dynamic cycles. That testing extended to lower pressure levels as shown in Figure 13. At seal pressure above 20 psid (138kPa) the effective clearance is essentially unchanged during the 5 pressure cycles. Below that pressure there are differences among the static cycles but airflow measurements were stable and noise was unexpectedly absent. It is believed that leaf tip burrs (Figure 10), may be bridging the gaps to mitigate leaf vibration. Five additional dynamic cycles to a higher pressure of 120psid (827kPa) were performed. Results in Figure 14 show only minor variation in pressure verses effective clearance throughout the test series. The repeatability of PALS closure with pressure was again found to be stable with no evidence of hysteresis.

Figure 13: PALS Static Cycling After Wear-in

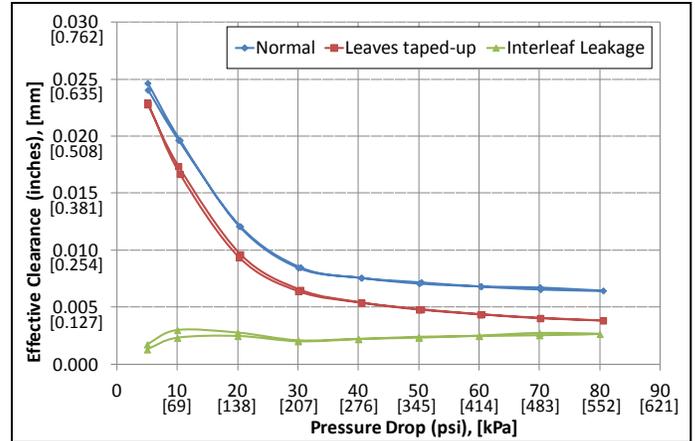
Figure 15: PALS Inter-leaf Leakage Assessment

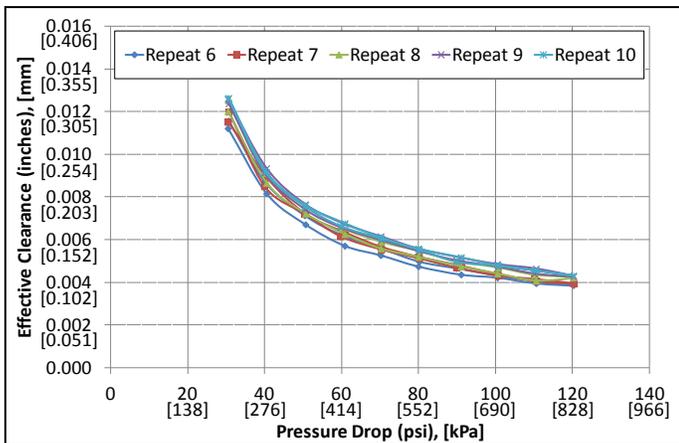
Figure 14: PALS Hi-Pressure Dynamic Cycling Clearance

The minimum effective clearance of 0.004 inches (0.1mm) is the same at 120psid (827kPa) as it was at 80 psid (552kPa) seal pressure. The incremental leaf tip deflection calculated for this seal is 0.001in (0.025mm) when seal pressure is increased to 120psid (827kPa) from 80psid (552kPa). It is worn away by leaf tip engagement with the rotor and results in a larger effective clearance at lower pressure as seen at 80psid (552kPa) in Figure 15. To assess the contribution PALS interleaf leakage to the minimum effective clearance, tests were run after the protective shroud was machined away to expose the seal leaves. The first test established a base line with seal leaves exposed normally. In the second, insulation tape covered the up-stream face of leaves to prevent passage of air between them. The difference in measured effective clearance is attributed of interleaf leakage. Results in Figure 15 show the effective clearance of interleaf leakage at 80 psid (552kPa) to be approximately 0.0025in (0.064mm). The rest of minimum measured effective seal clearance of 0.004in (0.1mm) is attributed to leakage at the seal backing ring and run-out of the rotor seal surface.

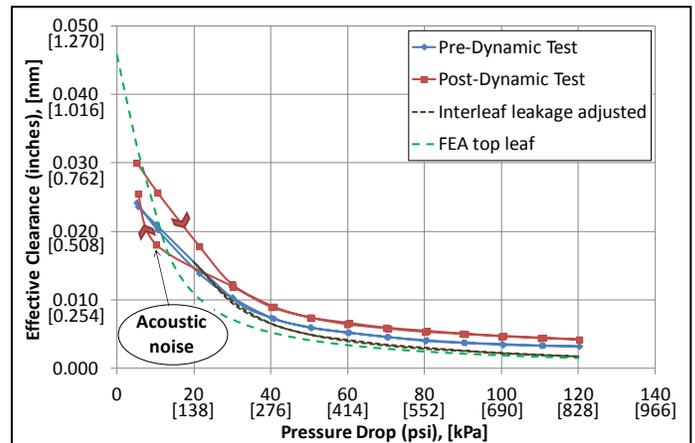
PALS closure observed after ‘wear-in’ with the 5.133in. (130.38mm) diameter disk was compared to that predicted by the FEA model. Using the measured un-deflected seal leaf ID of 5.202in (132.13mm) the calculated FEA seal closure, tracks very closely to measured effective clearance when an adjustment is included for measured interleaf leakage. The favorable comparison (Figure 16) confirms accuracy of design analysis. Acoustic noise was present from 30psi to 0psi when reducing the pressure back to ambient. As a result there is a reduction in effective clearance compared to when applying the pressure. This reduction in effective clearance is due to the oscillation of the leaves causing disturbed flow and irregular pressure transducer readings.

Figure 16: PALS Post Test Closure Analysis

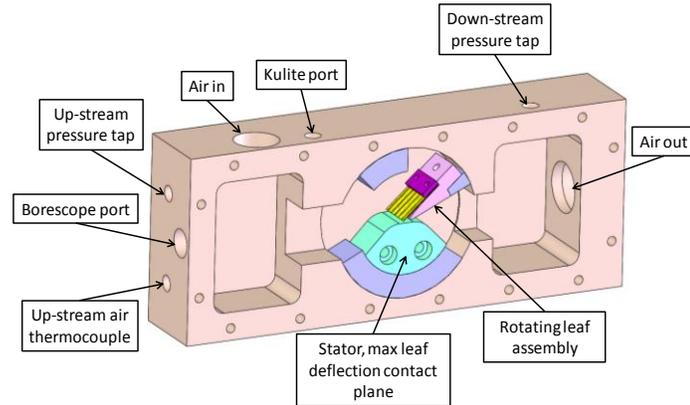
Figure 17: 2D Leaf Test Rig Design

A special test rig was designed and constructed which facilitated experimentally varying seal parameters in a well-controlled manner while providing access for good visual observation and accurate measurement of seal behavior. Shown in Figure 17 & Figure 18, the 2D Leaf Test Rig consists of a pressure vessel body with chambers upstream and downstream of a rotating leaf assembly in the round chamber. The leaves can easily be positioned to adjust the distance from the contact

demonstrate a design that is free from leaf vibration and noise. It started with the whole team conducting a brain storming activity to list all potential causes. In all, eleven possible causes were identified, Table 1. A test plan was then formulated to positively prove or disprove each of the possible causes of noise. This test plan involved a series of tests in both the 5.1in (130mm) test rig (Figure 7), and the 2D Leaf Test Rig (Figure 17).

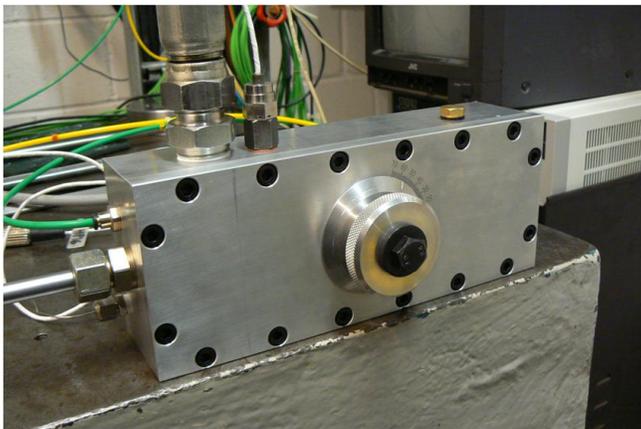
Figure 18: 2D Leaf Test Rig Photo

plate that simulates a rotor surface. The whole assembly can be rotated to vary the approach angle of the flow and the leaves can be rotated relative to the contact plate to obtain a wide range of angles between the leaves and the plate. Ports for measuring pressure and temperature are visible in the figure. This configuration also made it easy to place thin shims

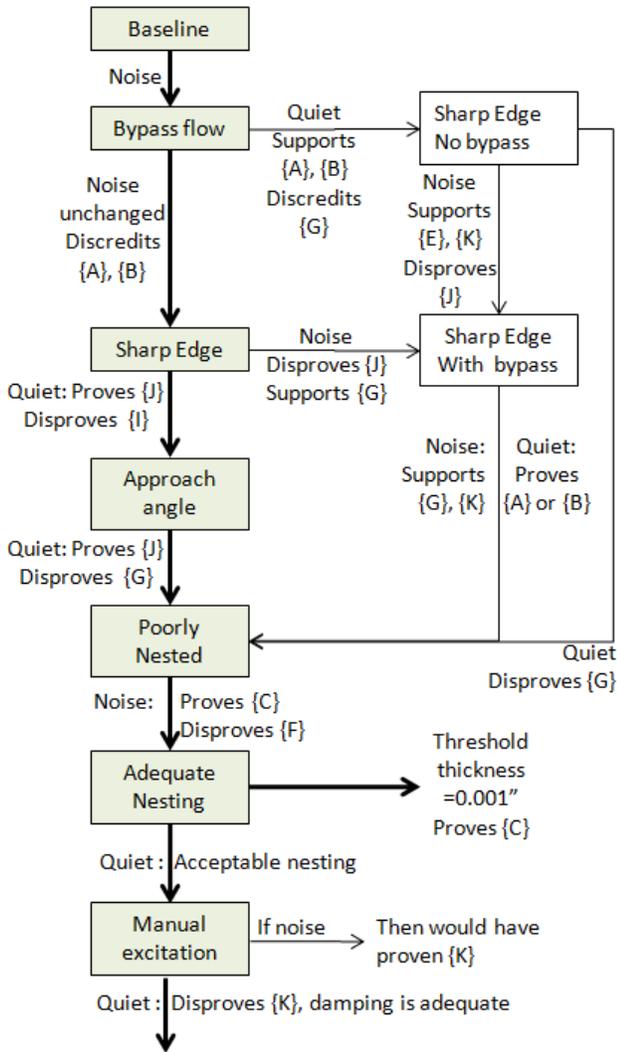
Figure 19: Sequence for Testing in 2D Leaf Test Rig

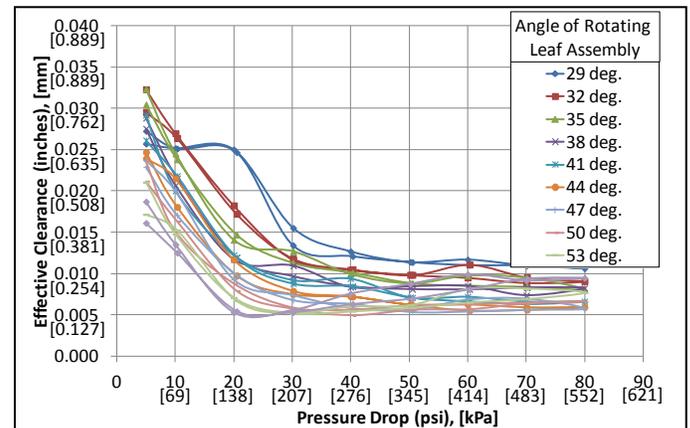
If vortex shedding from the leaf tips was causing leaf vibration then the approach angle between the airflow and the leaves should be a key factor in controlling the vibration, {G}. A series of tests was performed in the 2D Leaf Test Rig in which the leaf support was rotated to different angular positions. The entire assembly rotated as a unit, so only the flow approach angle was being changed. Figure 20 shows that the effective clearance and rate of closure changed as the assembly was rotated over a range of leaf angles from 29 to 56 degrees. This is accounted to the fixed geometry of the rotating leaf assembly. At large angles the leaf deflection is sufficient for the leaf tip to nearly contact the simulated rotor, however, as the angle is reduced the deflection becomes restrained by the support plate geometry and the leaf is too short to reach the simulated rotor. Consequently, for the rotating leaf assembly, as the leaf assembly angle increases the tip clearance decreases. All angular positions tested remained quiet; therefore hypothesis {G} was eliminated.

Figure 20: 2D Leaf Clearance, Varying Leaf Angle

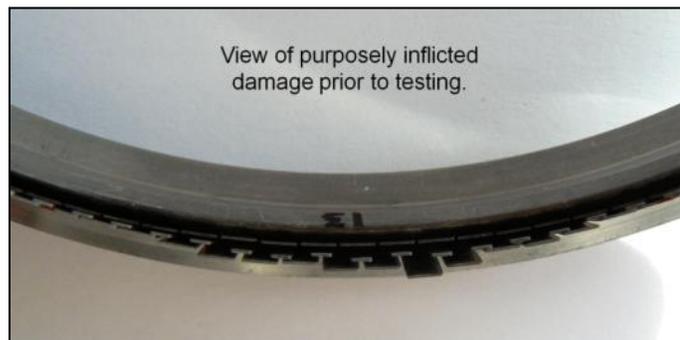
It still remained to determine whether a burr on the ends of the leaves resulting from the machining was providing contact between layers of leaves or providing added damping. This was especially interesting because when the first prototype seal was tested in the 5.1in (130mm) test rig it had leaf vibration and noise up to 30 psid (207kPa) on each of the early tests. Once a wear-in test was performed in which a larger diameter rotor was used to assure that the leaves would contact the rotor as pressure was increased, the seal was silent for all subsequent testing at all pressures. Hypothesis {E} also involved burrs, speculating that vortex shedding from the leaf tips excited the leaves and after wear-in the burrs on the leaf tips changed the character of vortex shedding, explaining why noise stops. To test these hypotheses, {D} and {E}, the 5.1in (130mm) test rig was used.

Figure 21: Seal with Intentionally Damaged Leaves

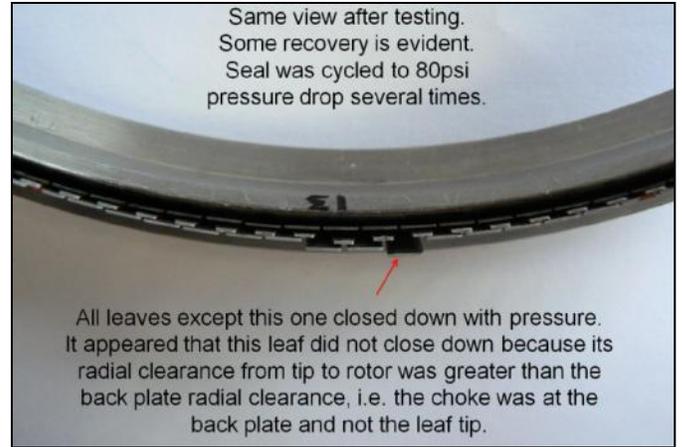
Figure 22: Intentionally Damaged Leaves, Post Testing

After thorough inspection of the seal used for initial testing, the rig was reassembled and static (non-rotating) and dynamic (rotating) tests were repeated. As was the case for all testing after the wear-in test, there was no leaf vibration and no noise at any pressure level, with or without bypass flow. Then the seal was removed and clamped into a fully-deflected condition. A wire EDM was used to remove burrs, cutting a new chisel-edge to 5.128in (130.25mm) diameter fully deflected. Remaining burrs were removed by hand. It was reassembled into the test rig with the same 5.133in (130.25mm) diameter rotor. Tests were performed, taking care to limit the differential pressure to assure that the leaves did not rub the rotor. There was a slight hum detected as the flow was initiated, but effectively the leaf vibration and noise were still absent. This seemed to indicate that burrs were not a factor, disproving {D} and {E}. However, one additional possibility was considered. If HCF cracking had occurred because of the length of time that the leaves had been allowed to vibrate then that could have altered the stiffness and the natural frequency or provided some damping. So, the seal was removed from the test rig and examined by microscope and dye penetrant for indications of HCF. None were found, eliminating hypothesis {H}.

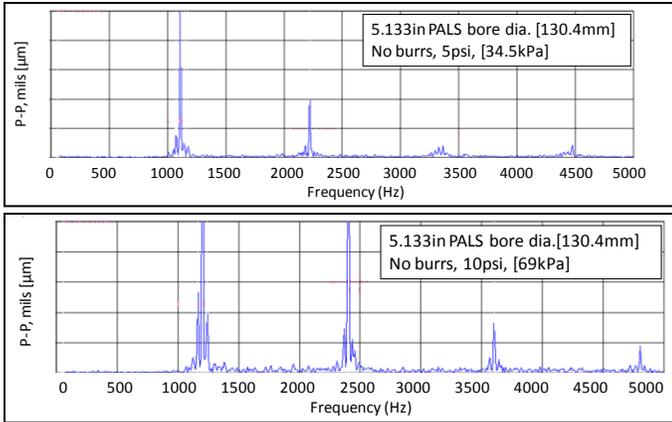
As the 2D test rig has indicated that the interleaf gaps result in leaf vibration and noise at low differential pressures a test of the impact of handling damage was conducted. Starting with the seal for the 5.1in (130mm) test rig which was quiet for all conditions, leaves were manually bent up to simulate handling damage (Figure 21 & Figure 22). Strong vibration and a loud noise resulted at 5 and 10 psid (34 and 69kPa), (Figure 23). One leaf that had been deflected to a tip radius greater than the support inner diameter did not close under pressure. Several cycles to 80 psi (552kPa) yielded repeatable results with no change in the appearance during the test (Figure 23). This test confirmed that interleaf gaps can lead to the initiation of vibration and noise.

Figure 23: Damaged Seal Noise Signal at 5 and 10psi respectively

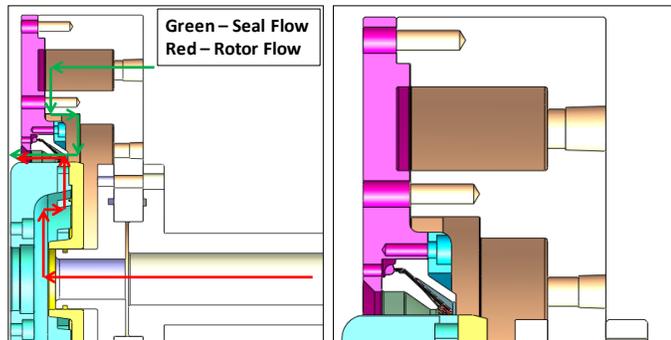
The PALS simulated turbine blade test installation can be seen in Figure 24 & Figure 25 using the 5.1in (130mm) test rig. The test was conducted on a 5.12in (130.0mm) diameter rotor with 12 equal spaced step and slot combinations round the circumference of the rotor.

Figure 24: Shrouded Rotor Test Schematic with Air Flow Path

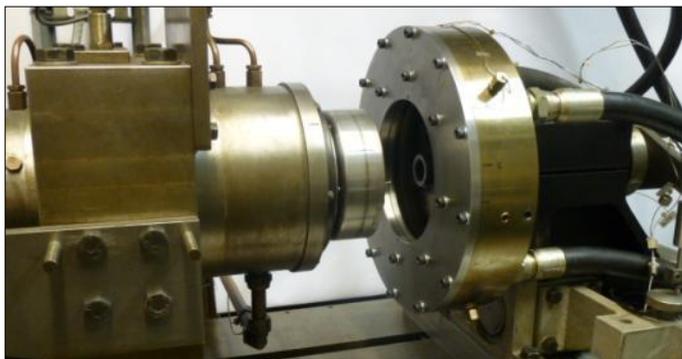
Figure 25: Shrouded Rotor Test Setup

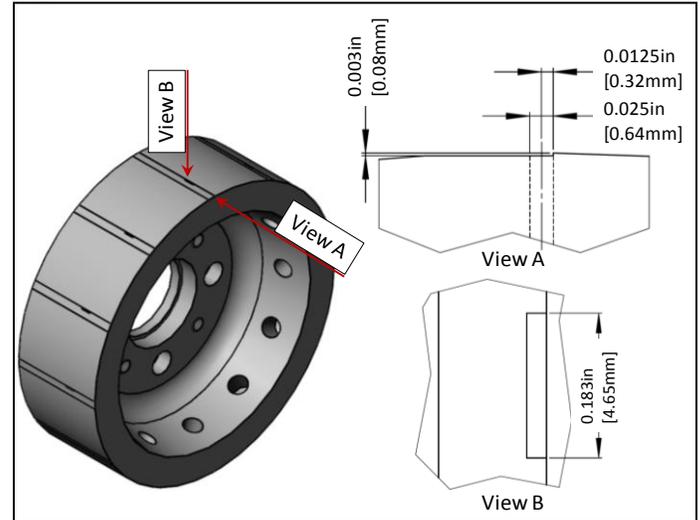
The radial height of each step was 0.003in (0.076mm) with slots allowing for radial air to be injected under the seal leaves (Figure 26) at a higher pressure than that at the front of the leaves. This type of rotor set-up simulates any discontinuation of the shroud sealing surfaces as typically seen in steam turbine

Figure 26: Rotor Slot and Step Detail, 12 Places

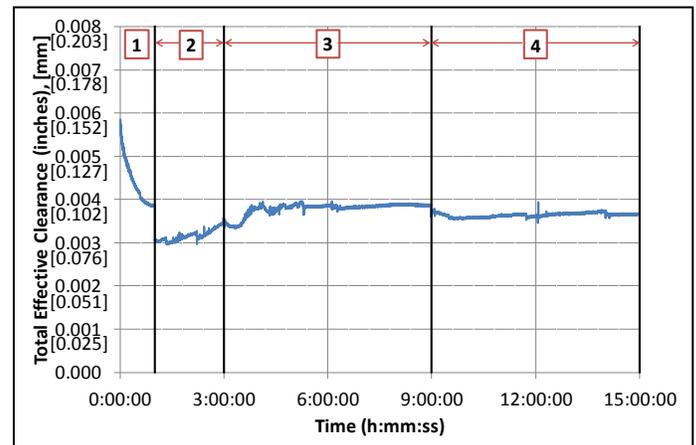
A 15 hour steady state dynamic test was conducted with a seal pressure of 55psi (379kPa), rotor pressure of 65psi (448kPa) and venting to atmosphere in both instances. The rotor speed was held at 20,000rpm, equating to a slot frequency of 4000Hz. The seal had a cold clearance of 0.018in (0.5mm) and an initial deflected leaf to rotor interference of 0.003in (0.076mm). The test was broken down into 4 intervals with inspections taken at 1hr, 3hrs, 9hrs and 15hrs. The rotor and seal flow were measured independently of each other to calculate the effective clearance in both instances, with the total effective clearance being reported. The results for total effective clearance in Figure 27 show a period of wear in before stabilization. The seal first experiences an increase in sealing performance as the leaves bed-in to the rotor from ~0.006in (0.152mm) to ~0.004in (0.102mm) total effective clearance during the initial hour long test. The seals performance then decreased gradually over a period of 3 hours by ~0.001in (0.025mm) total effective clearance before stabilizing between 0.0035 (0.089mm) and 0.004in (0.102mm) for the remaining 11 hours.

Figure 27: Total Effective Clearance over the 15hr Test with Test Breakdown Intervals Shown

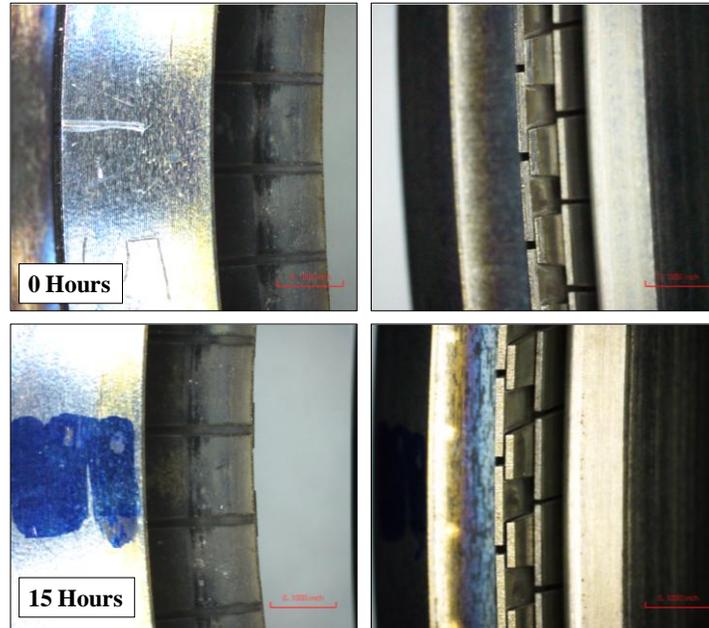
The seal was inspected at intervals through the testing with a comparative on leaf wear shown in Figure 28. The seal was EDM cut with only shakedown wear to the tips at 0 hours of testing. After the 15 hour simulated shroud test, wear was visible to the leaf tips, with small burr formation on both the top and bottom leaves (Figure 29). In total the free diameter of the bore increased by 0.008in (0.2mm) from 5.156in (130.96mm) to 5.164in (131.17mm) and the leaf tips became profiled to an angular deflection relative to the rotor.

Figure 28: Leaves at 0hr and 15hrs of Testing

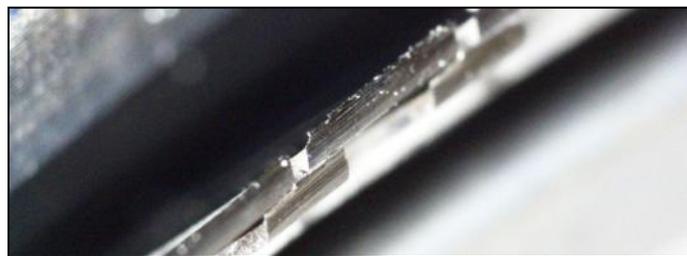
Figure 29: Burr Formation in Both Top and Bottom Leaves

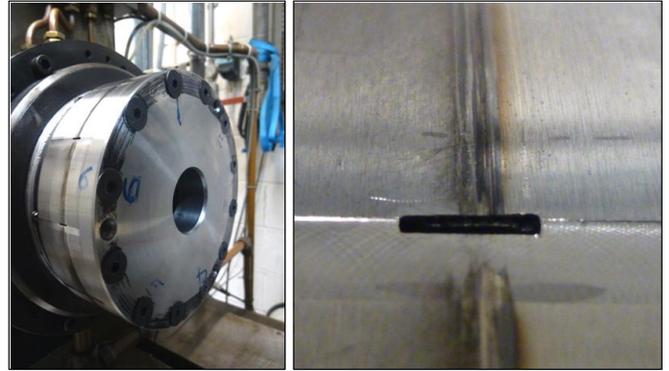
The rotor wear track was again visible, with some heat generation marking on the upstream side of the track (Figure 30) generated at the point of initial contact and wear. The majority of the track was created within the first 3 hours, with the wear track at 0.0001in (0.0025mm) depth after 1 hour of running and only 0.0003in (0.0076mm) after the full 15 hour test as seen in Figure 31. The results for the total effective clearance and wear traces indicate that frictional heating has minimal influence on sealing performance after the designed wear-in stage.

Figure 30: Rotor Wear Track at 15hrs of Testing

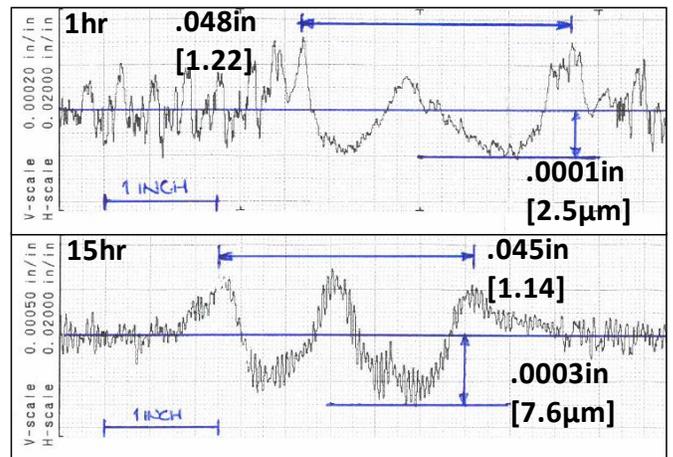
Figure 31: Rotor Wear Traces after 1hr and 15hrs of Testing

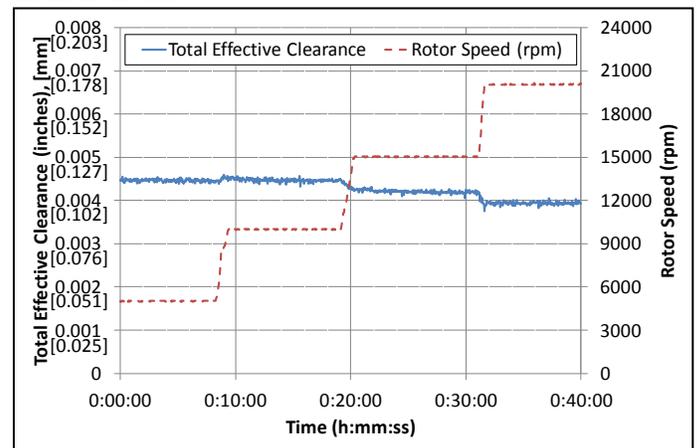
A reverse rotation test was carried out with a seal pressure of 55psi (379kPa), rotor pressure of 65psi (448kPa) and venting to atmosphere as per the 15 hour test. The test was run at speeds from 5000rpm to 20,000rpm and held for approximately 10 minutes at each speed. The results in Figure 32 demonstrate the seals ability to run in the reverse direction, against the steps. Further, the total effective clearance improved with speed and at 20,000rpm the results were comparable to that measured in the 15 hour test.

Figure 32: Total Effective Clearance running Reverse Rotation at

Varying Speeds

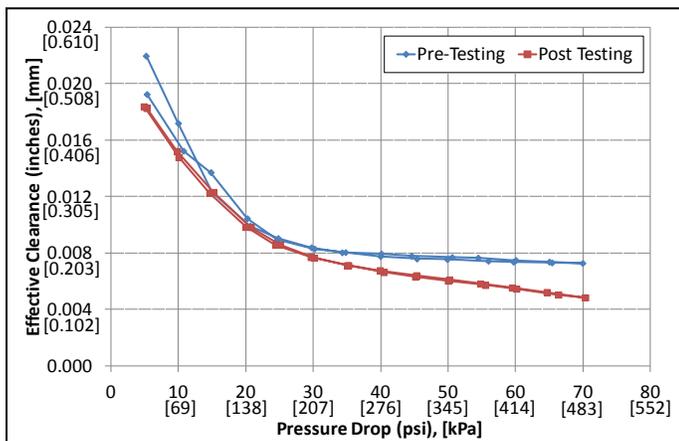
Finally static leakage tests were conducted pre and post testing with the results shown in Figure 33. These were undertaken with the leaves located over the slots, increasing the seal pressure from 0-70psi (0-483kPa). No rotor pressure was applied and the air path to the slots closed. At pressures below 20psi (138kPa) the pre-testing static leakage encountered leaf oscillation as seen by the discontinuity of the total effective clearance when applying the pressure verses removing the pressure. The leaf oscillation was not present on the post-testing static leakage test. Pressures above 20psi (138kPa) show an improvement on total effective clearance from pre to post-testing as a result of the leaf wear in. There is also an increase in effective clearance when comparing static to dynamic results. This can be attributed to the radial growth of the disk due to rotation.

Figure 33: Static Leakage Results Pre and Post Testing
